# Manhole Inspection Summary

Manhole # S49M\_\_016MH

**Inspection** ☐ Is Incomplete Rating: **3) Fair**

**Location** Address: **825 alley fait hudson**

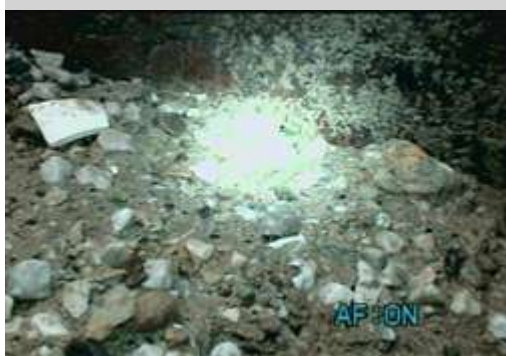
Defect 4

Condition: ☐ Sound ☐ Cracked ☐ Root Intrusion ☐ Deteriorated ☐ Leaks ☒ **Debris**

bench debris

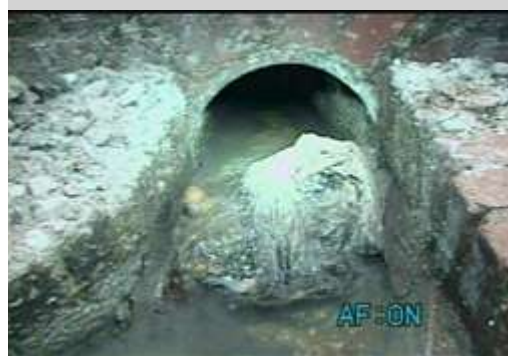
Defect 3

Condition: ☐ Sound ☐ Cracked ☐ Root Intrusion ☐ Deteriorated ☐ Leaks ☒ **Debris**

channel debris

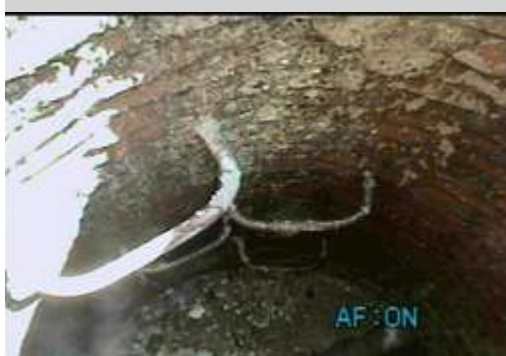
Defect 2

**Steps** Count: **4** Missing: **0** ☒ **Corroded**

corroded stairs

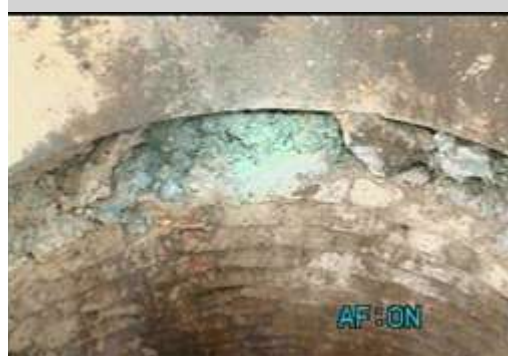
Defect 1

Condition: ☐ Sound ☐ Cracked ☐ Root Intrusion ☐ Loose Brick ☒ **Deteriorated**

chimney cond deteriorated

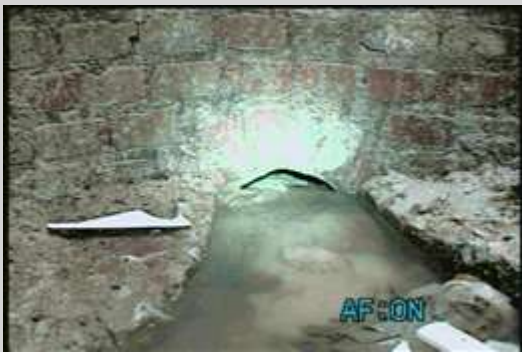
12 O'Clock Outflow

Pipe Height: **0** (in.) Direct  
Pipe Material: **Clay** ☐ Pipe Lined  
Invert Depth: **8.41** (ft.) Flow Characteristics: **Slow**  
Deposits: ☐ None ☐ Mud ☐ Sludge ☒ **Debris** ☐ Grease  
Silt Depth: **7** (in.) Deposits Extent: **Heavy**  
Infiltration: **None** Pipe Seal Cond: **Unknown**

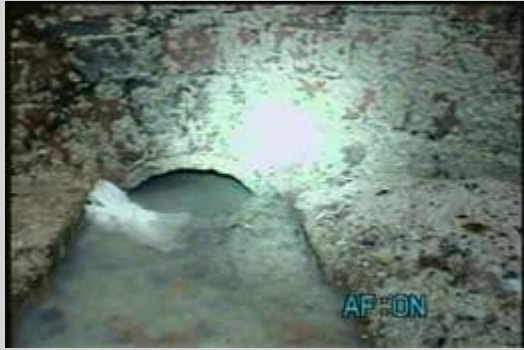
9 O'Clock Inflow

Deposits: ☐ None ☐ Mud ☐ Sludge ☒ **Debris** ☐ Grease

Silt Depth: **7** (in.) Deposits Extent: **Heavy**
